**Failure Analysis, Cadmium Brush Plate Qualification and  
Salt Fog Testing of the AH-64 Shock Strut Mount,  
P/N 7-311113409**

**ARL-TR-2870**

**November 2002**

**Weapons and Materials Research Directorate, ARL**

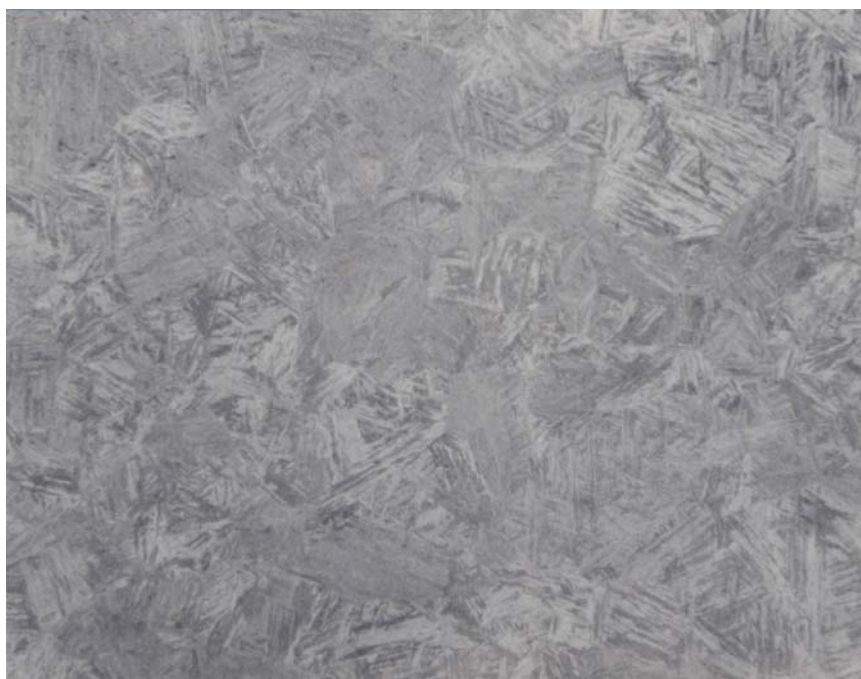
Figure 12. Microstructure of the material showing aged, low-carbon martensite in the longitudinal direction. Marble's Reagent (mag. 50H).

between nos. 2 and 3 at 100H magnification using the ASTM E112 charts over Figure 12. To verify this, a photomicrograph was taken using a grain size reticle, as shown in Figure 14. Again, the size was between nos. 2 and 3. The ASTM E112 charts indicate that the nominal diameter of the average grain is between 0.005 and 0.007 in, respectively for a grain size of nos. 3 and 2. A photomicrograph was subsequently taken of this structure at 100H, using an incremented reticle (Figure 15). As shown, the grain appear to have diameters ranging from 0.005–0.01 in, which correlated to the previous measurements. Subsequently, the intergranular fracture surface shown in Figure 18 (also see section 2.8) was also examined for grain size using the ASTM E112 “Fracture Grain Size” method. This technique is typically used for high-hardness, brittle steels with a predominantly martensitic structure, such as tool steels, high-carbon steels and martensitic stainless steels, and should be done with the specimen in the as-quenched or lightly tempered condition. Even though the Maraging 300 steel is a low-carbon alloy, the results obtained compared favorably to those from the other three methods. From Figure 18, the grain size ranged from ~100–200  $\mu\text{m}$ , which correlated to a range of 0.004–0.008 in.

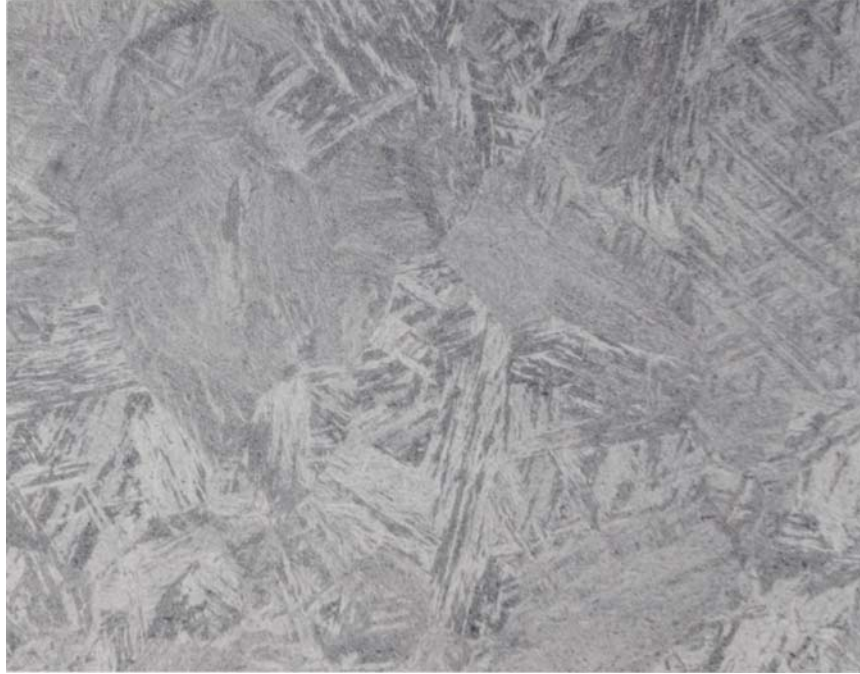
Figure 13. Microstructure similar to that in Figure 12 shown at higher magnification and in the transverse direction. Marble's Reagent (mag. 100H).

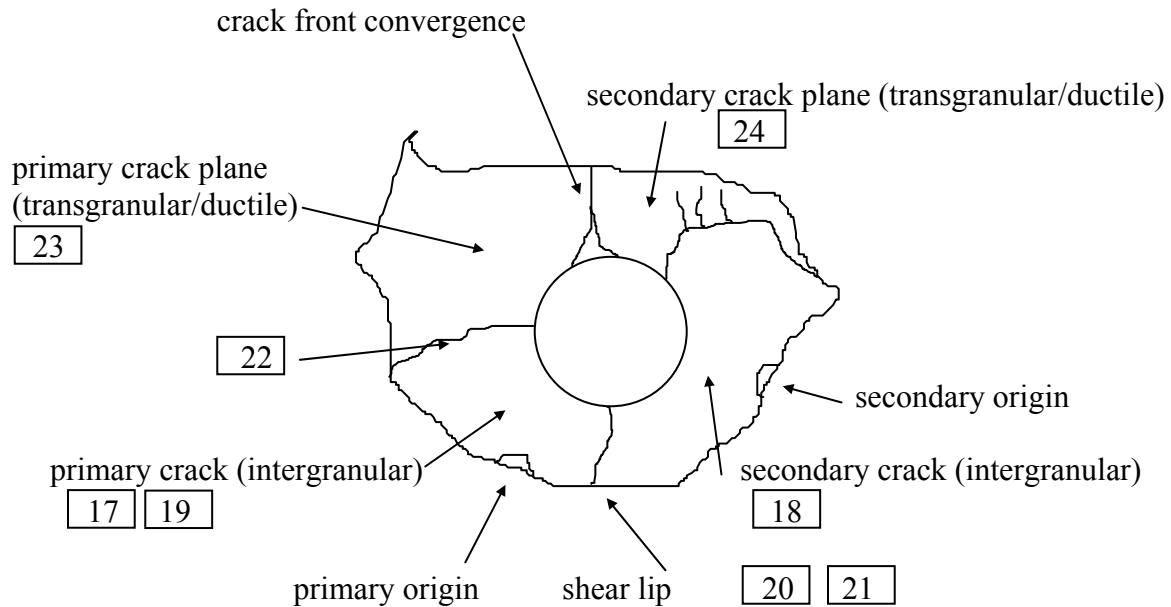
The fracture surface of the component was subsequently examined using the scanning electron microscope (SEM) in order to determine the fracture morphology and fracture mechanism. The fracture surface was ~50% intergranular (the primary crack comprised 20%, while the secondary crack was 30%). Figure 16 is a schematic showing the fractographic features of the surface. The

Figure 16. Schematic of fracture features as determined through SEM. Numbers in boxes correspond to figure locations.

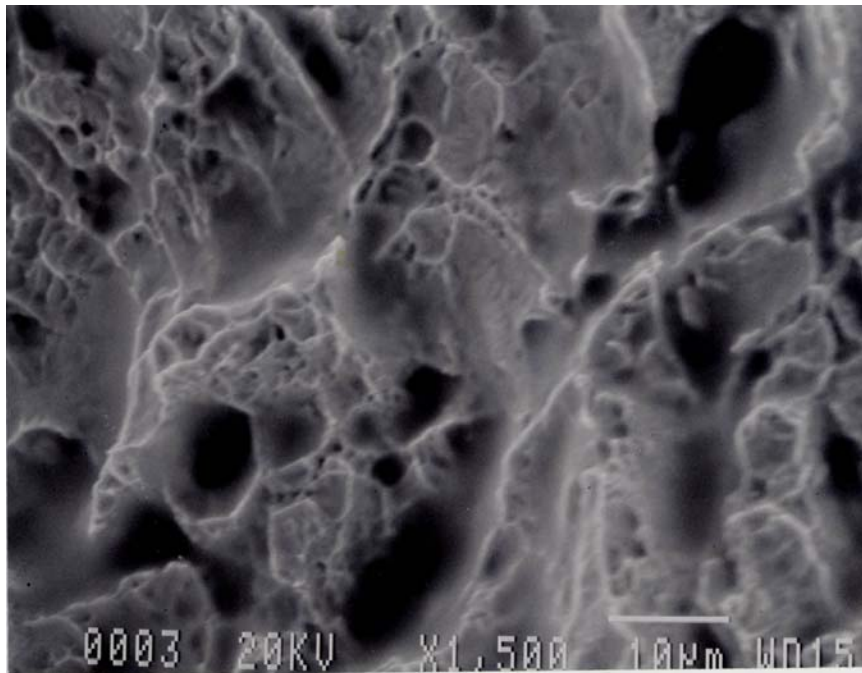
Figure 20. Ductile morphology noted within shear lip between the primary and secondary fracture (mag. 1500H).

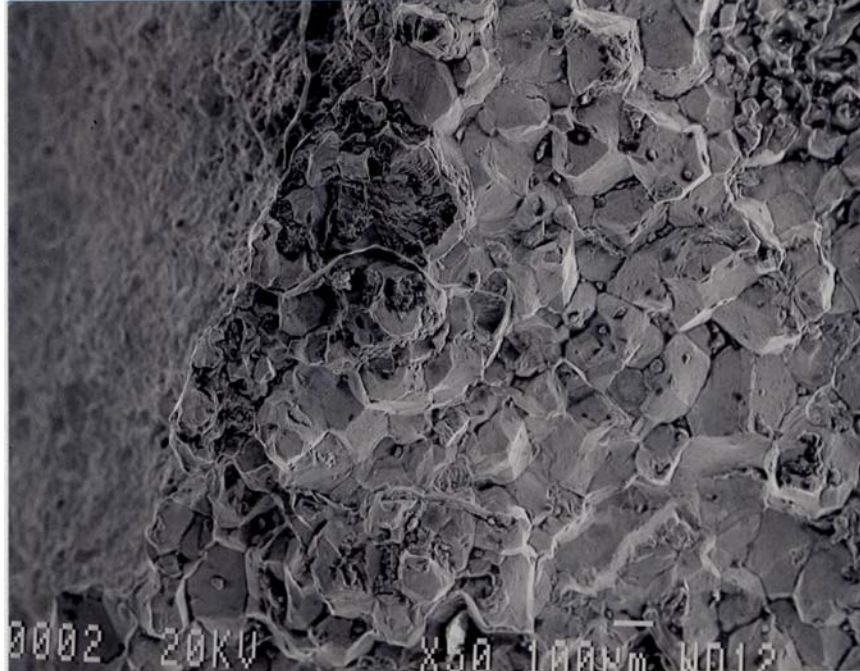
Figure 21. Interface between the secondary fracture surface and the shear lip (mag. 50H).

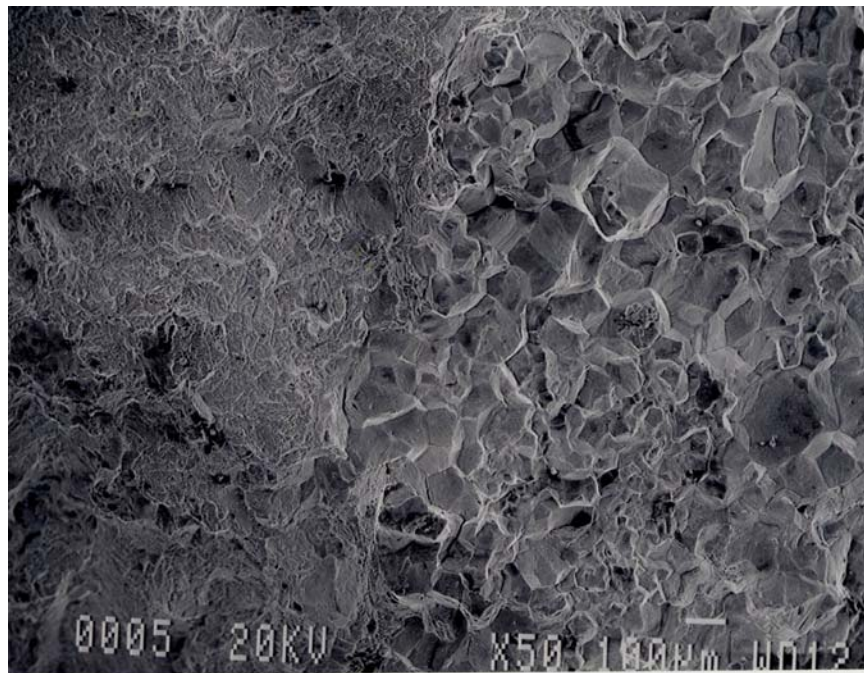
Figure 22. Interface between the primary fracture surface and the transgranular/ overload region (mag. 50H).

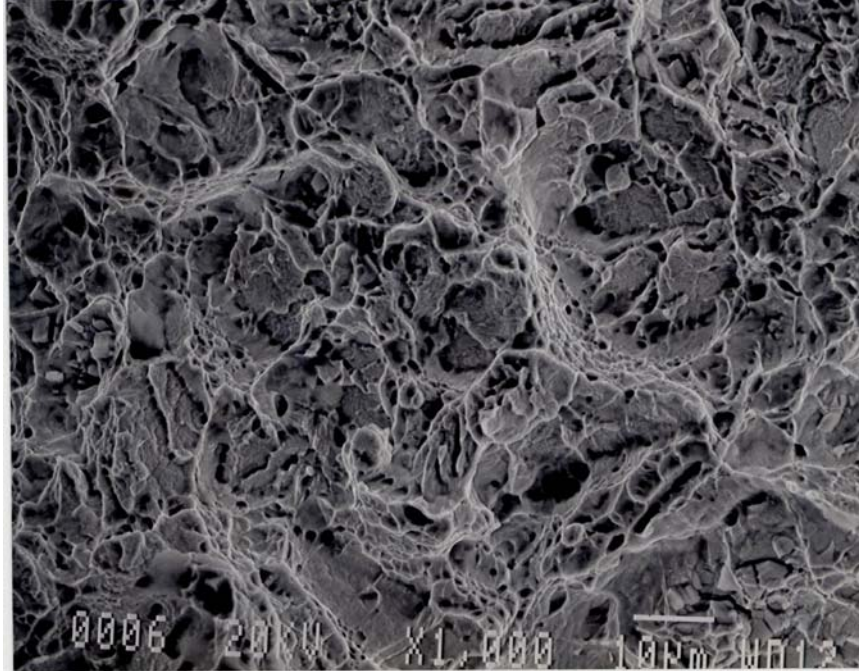
Figure 23. Morphology of the surface on the same plane as the primary fracture surface subjected to fast-fracture, consisting of a transgranular/ductile mode (mag. 1000H).

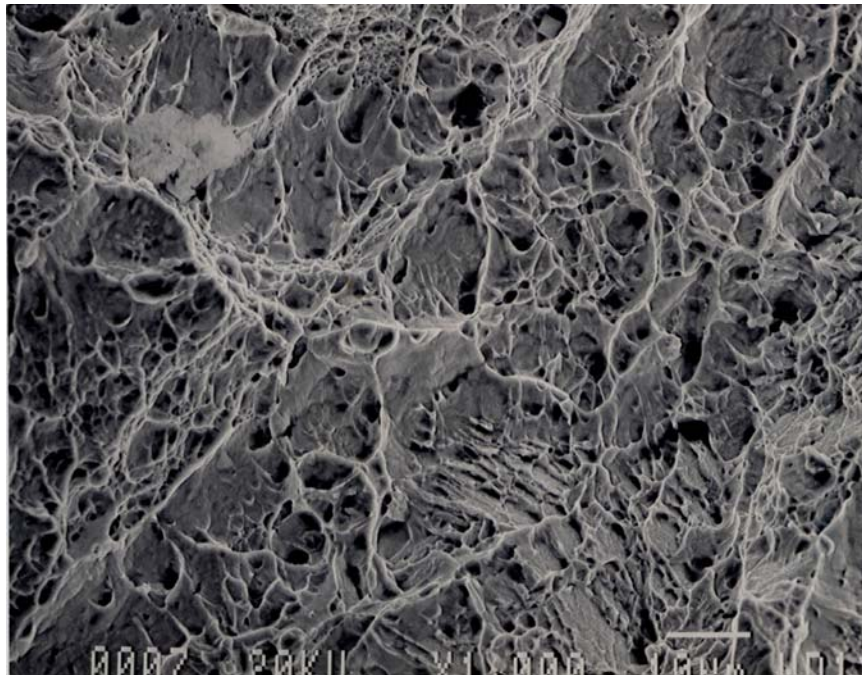
Figure 24. Morphology of the surface on the same plane as the secondary fracture surface subjected to fast-fracture, consisting of a transgranular/ductile mode (mag. 1000H).

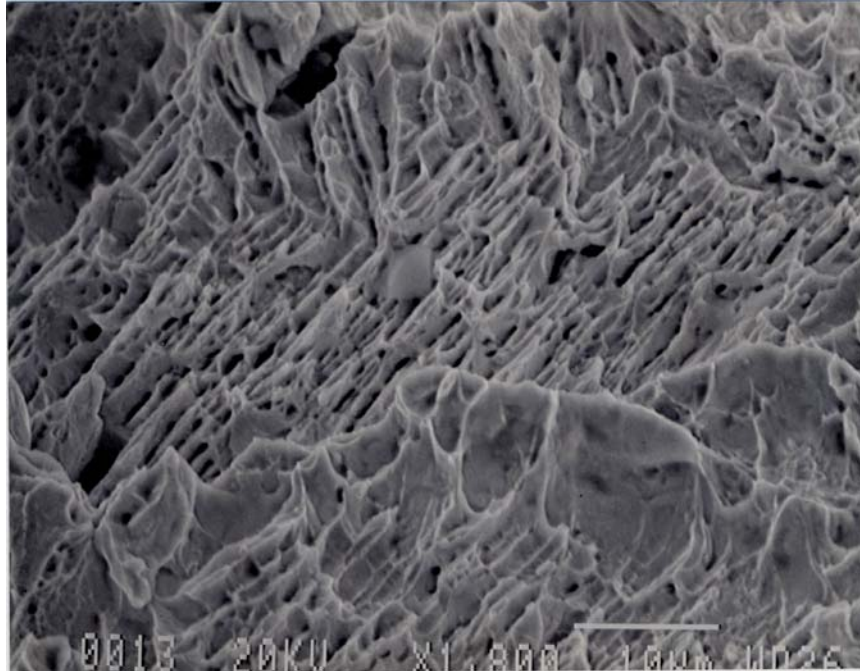
Figure 25. Transgranular/ductile morphology at higher magnification (mag. 1800H).

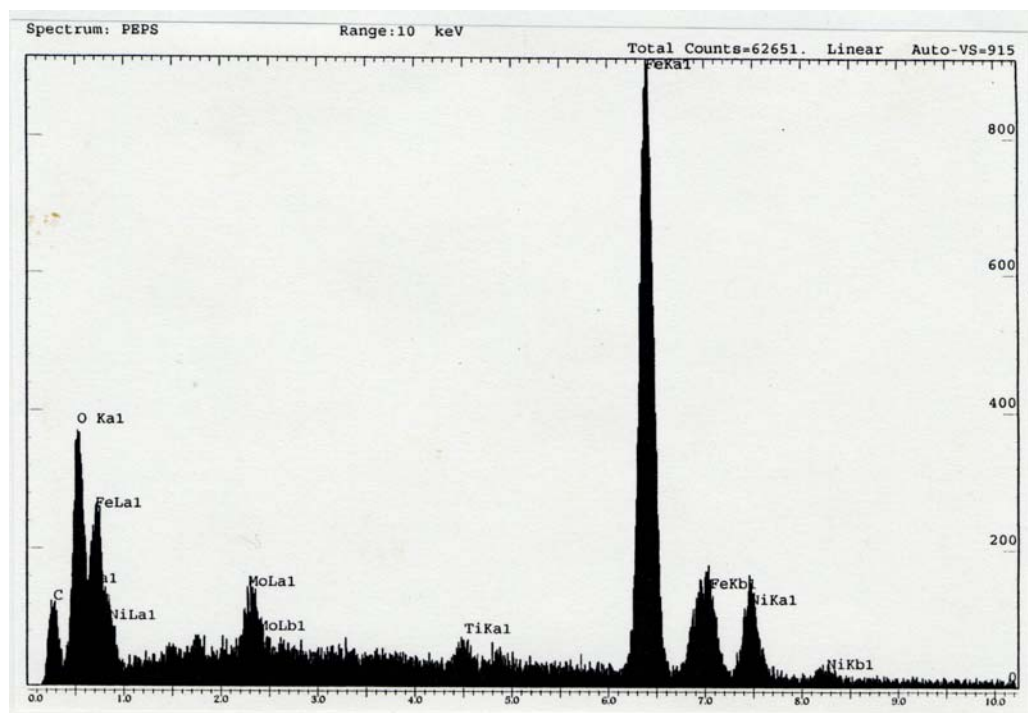
Paragraph 3.3.3d of Process Specification HP 1-1, “Steel, Nickel-Base and Cobalt-Base Alloys, Heat Treatment of,” states that maraging steel bars and forgings shall exhibit an aged martensitic structure, fine grained, with no evidence of titanium-carbonitride at the grain boundaries. The mounted samples were repolished and etched with ferric chloride (5-g  $\text{FeCl}_3$ , 50-mL  $\text{HCl}$ , and 50 mL of distilled water) in order to reveal the austenitic grain boundaries. EDS was subsequently used to determine the chemical composition of precipitates noted within the grain boundaries. Figure 28 shows an example of one of these precipitates (see white arrow). EDS of this precipitate (Figure 29) revealed a small amount of titanium, but no carbon or nitrogen. EDS was subsequently conducted on the intergranular fracture surface, in an attempt to locate Ti (C, N) precipitates along the grain boundaries. Figure 30 shows a precipitate on a grain boundary of the “rock candy” surface that was analyzed. The resultant spectrum is displayed in Figure 31. Note the high level of titanium as well as the presence of carbon and nitrogen. This was evidence of a titanium-carbonitride at the grain boundaries. Figure 32 shows an additional precipitate that revealed a similar spectrum.

Figure 29. EDS spectra showing evidence of titanium within the precipitate shown in Figure 28. Other elements constitute the alloy.

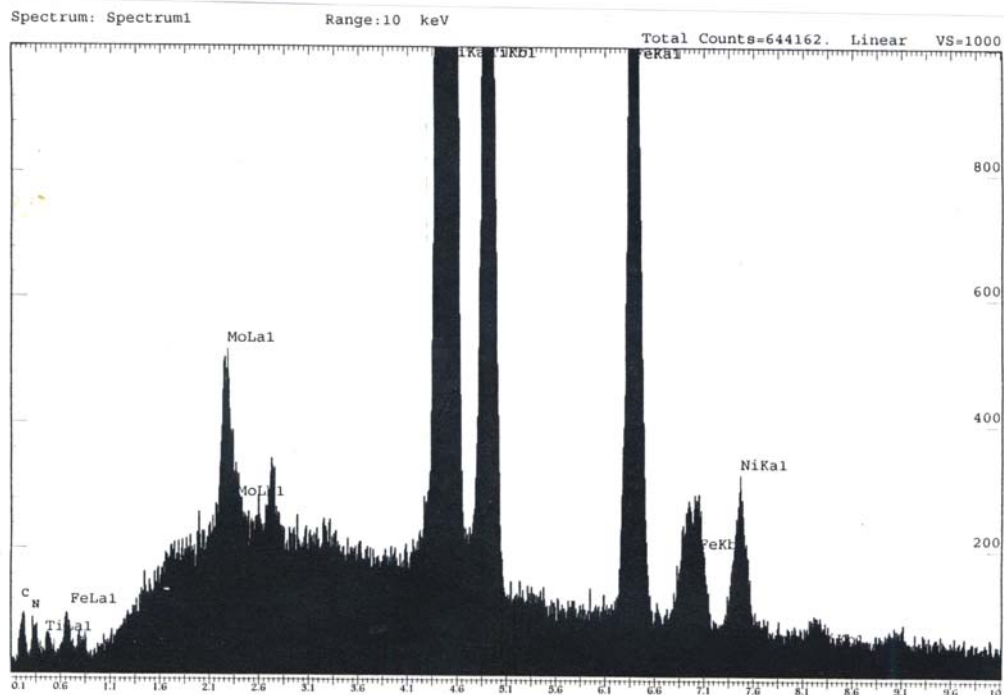
Figure 31. EDS spectra of the Ti (C, N) precipitate shown in Figure 30. Note the presence of titanium, carbon, and nitrogen, as well as the alloying elements.

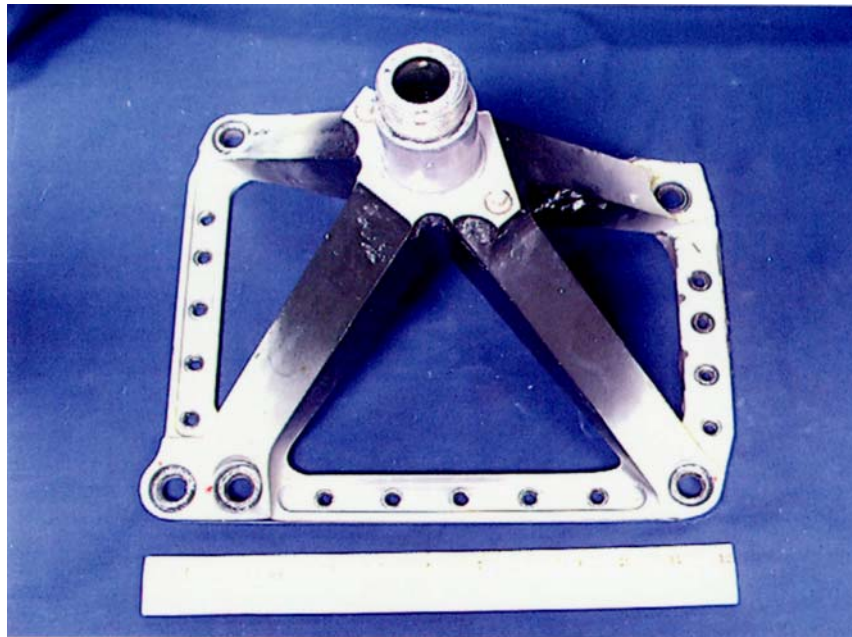
The U.S. Army Aviation and Missile Command (AMCOM) requested the qualification of two facilities for the cadmium brush plating of AH-64 landing support struts (shown in Figure C-1). The facilities would perform rework in the spindle to webbing radius that has been the origin of many failures over the past decade. As part of the qualification process, the U.S. Army Research Laboratory (ARL) performed hydrogen embrittlement testing on specimens that were cadmium brush plated by the Hunter Army Air Field (HAAF), Savannah, GA, and Ft. Lewis, WA. Each facility used a “no-bake,” non-embrittling solution for plating. The specimens were produced in accordance with American Society for Testing and Materials (ASTM) G39<sup>1</sup> from two separate AH-64 Landing Support Struts comprised of Maraging 300 Grade steel. Each specimen withstood 8 weeks of ambient exposure (75 °F and 50% relative humidity) at 80% and 92% ultimate tensile strength (UTS) loading without failure. Based upon the results of ambient loading, the two facilities were qualified to perform cadmium brush plating operations.

Figure C-1. Intact shock strut mount shown in the as-received condition (reduced 75%).

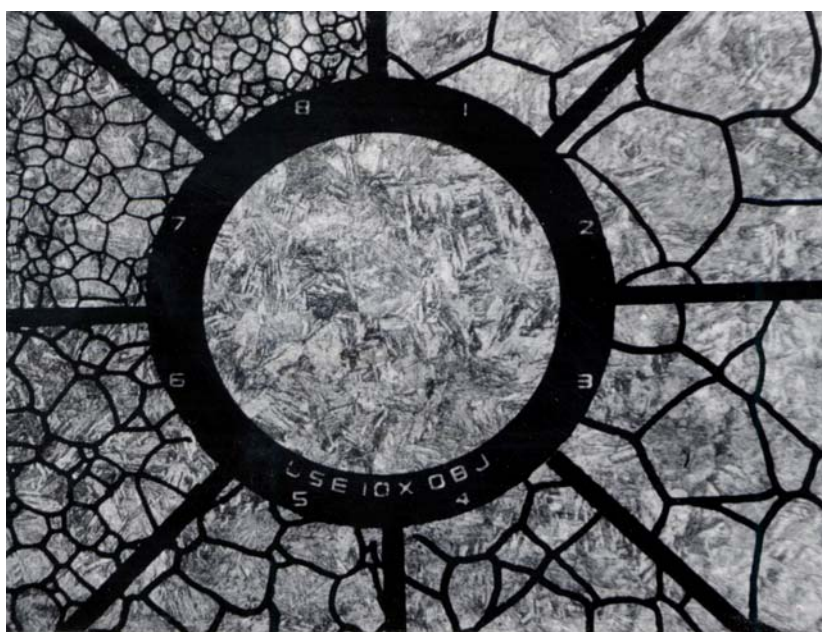
Figure C-3. Grain size of a representative HAAF specimen (mag. 100H).

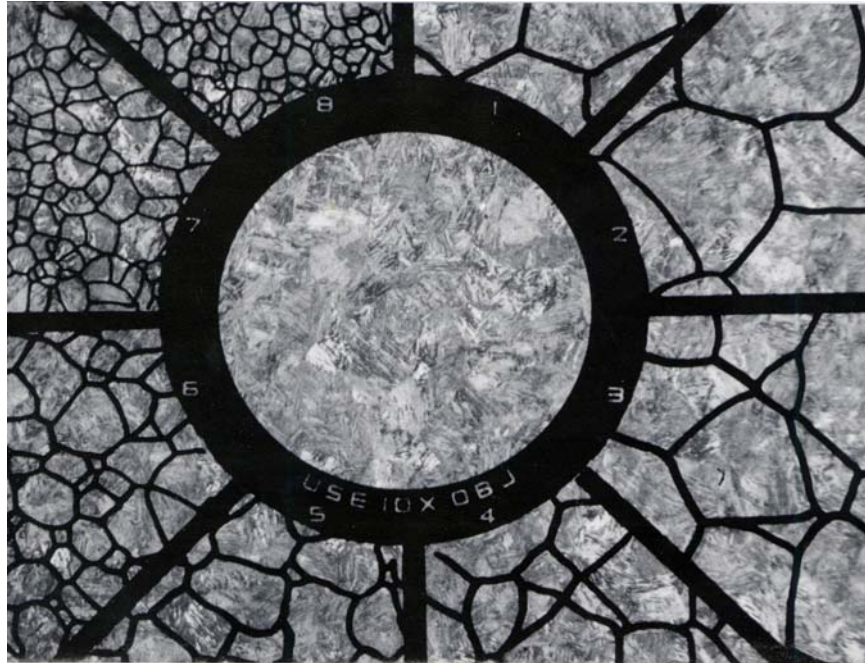
Figure C-4. Grain size of a representative Ft. Lewis specimen (mag. 100H).

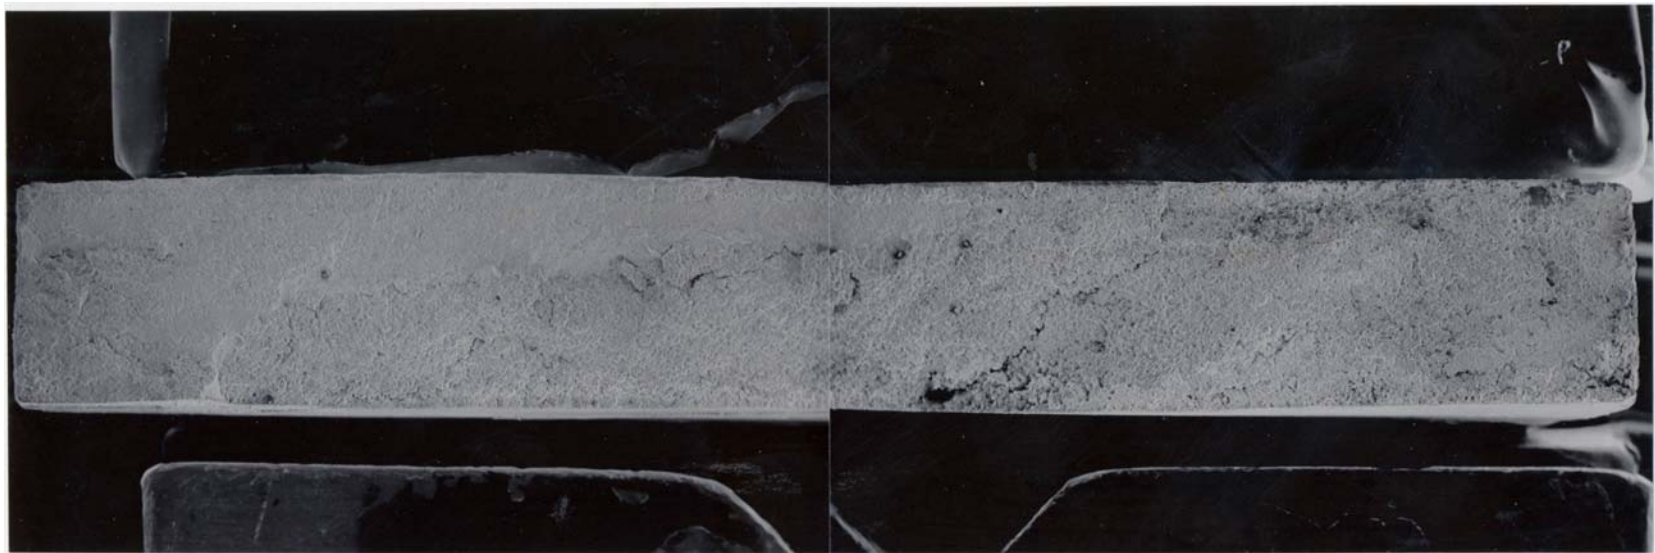
Figure C-5. Montage of a typical fracture surface of a HAAF specimen (specimen no. 1) (mag. 12H).

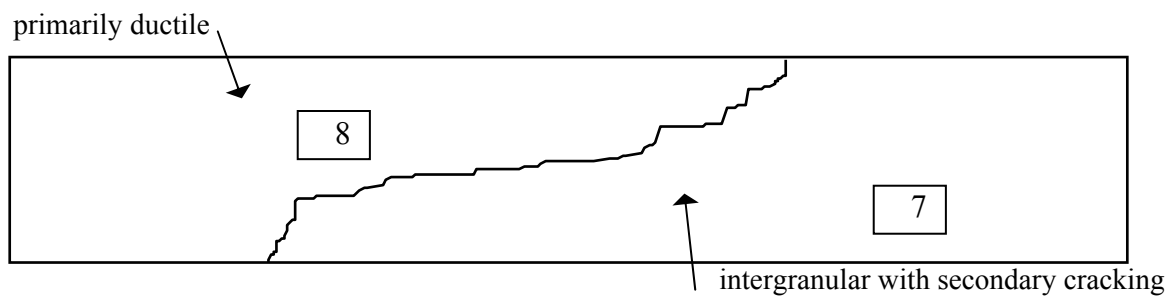
Figure C-6. Schematic illustrating a mapping of the fractographic features of the surface shown in Figure C-5. Boxes show locations of Figures C-7 and C-8.

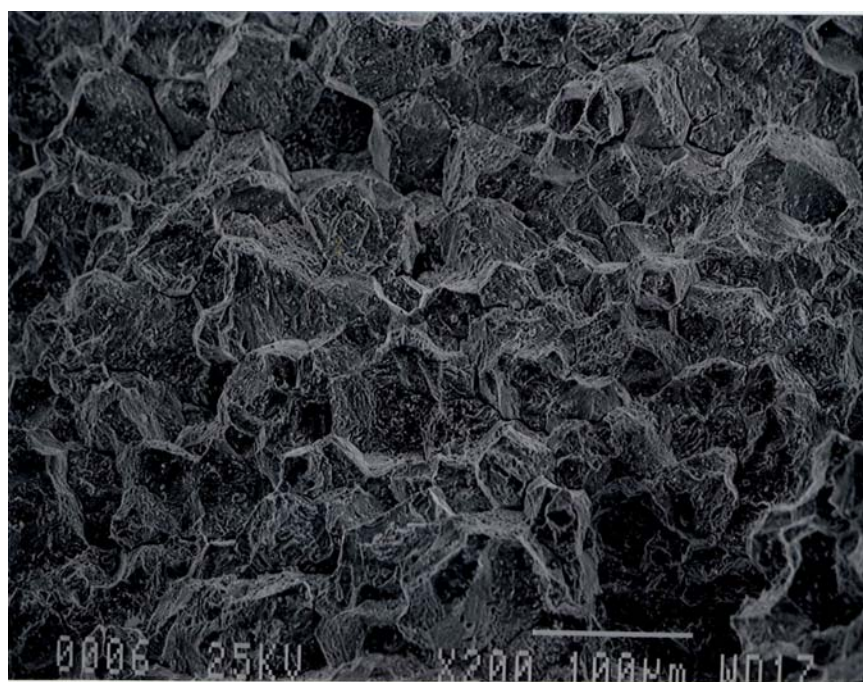
Figure C-7. Intergranular morphology prevalent on the HAAF specimens, indicative of a brittle fracture (mag. 200H).

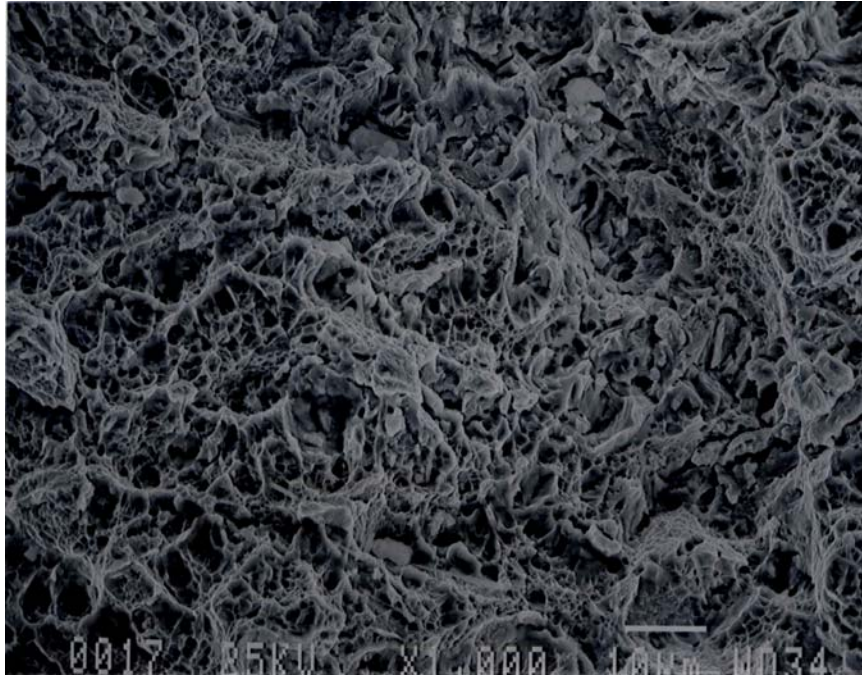
Figure C-8. Ductile morphology noted on the HAAF specimens, indicative of final fast fracture (mag. 1000H).

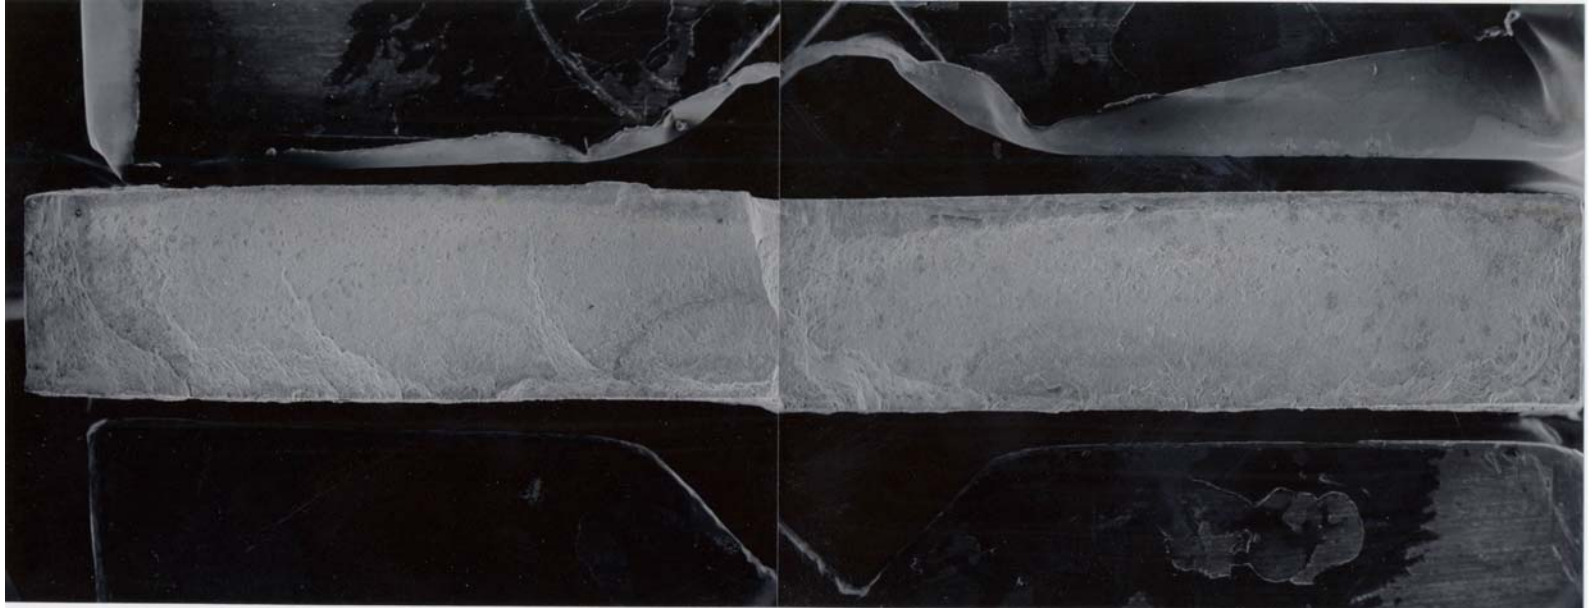
Figure C-9 contains a montage of a typical Ft. Lewis failure, while Figure C-10 contains the accompanying schematic map. The fracture surfaces of the broken Ft. Lewis specimens consisted primarily of a transgranular, quasi-cleavage morphology (Figure C-11). The fracture of one of the specimens consisted of two planes with three distinct origins on the tensile side of the specimen and had the appearance of a ductile fracture. The surface was predominantly transgranular with evidence of intergranular attack and secondary cracking only at each of the three origins. Ductile dimples were noted on the compressive side of the specimen, which was the last to fail. Figures C-12 through C-14 represent the three origins at 100H magnification, while Figures C-15 through C-17 show the origins at higher magnification (200H). Figure C-18 represents the morphology noted within the center of the specimen (mixed mode; ductile and transgranular) as illustrated in Figure C-10, while Figure C-19 represents the morphology of near the compressive side of the specimen. Figure C-20 is a high-magnification scanning electron micrograph representing the ductile region (final fast fracture) on the fracture surface.

Figure C-9. Montage of a typical fracture surface of a Ft. Lewis specimen (specimen no. 3) (mag. 12H).

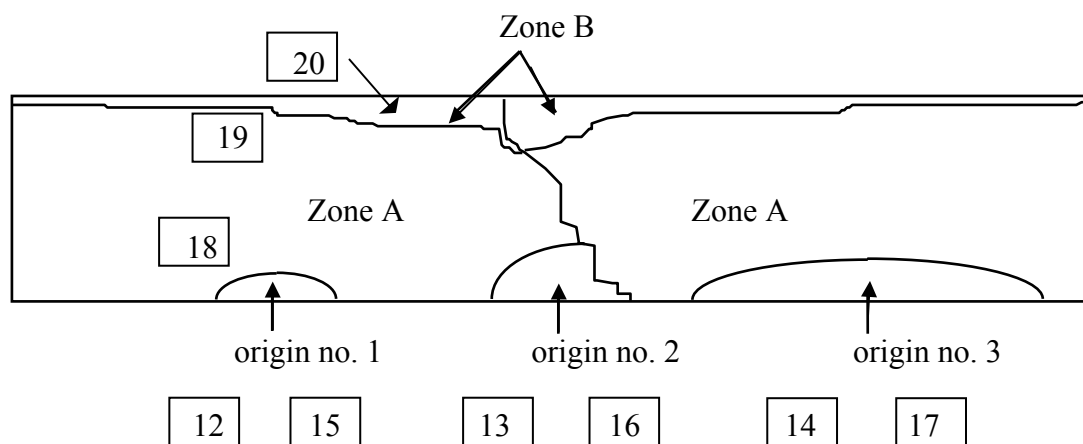
Figure C-10. Schematic illustrating a mapping of the fractographic features of the surface shown in Figure C-9. Boxes represent location of figures.

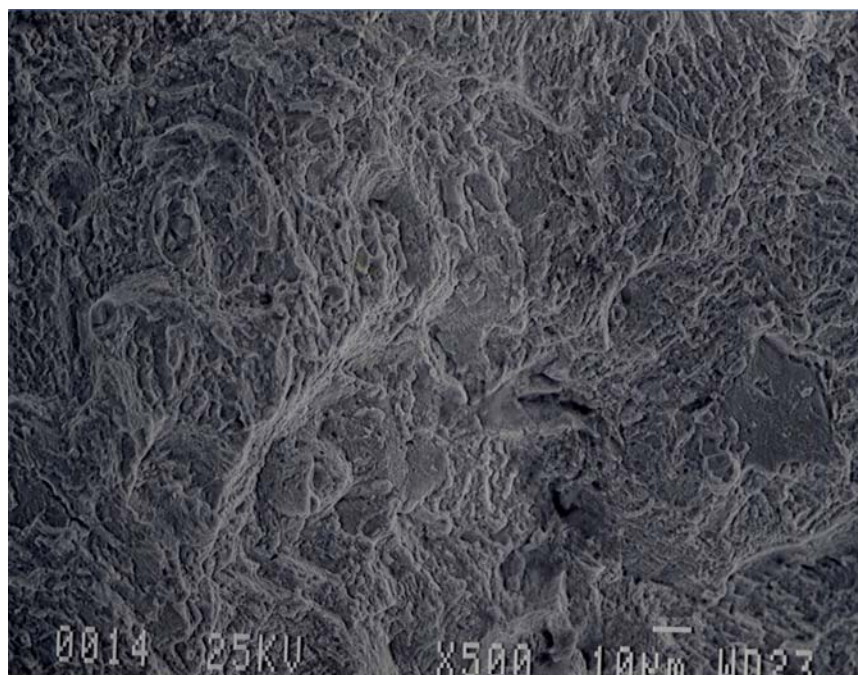
Figure C-11. Transgranular fracture morphology prevalent on the Ft. Lewis specimens (mag. 500H).

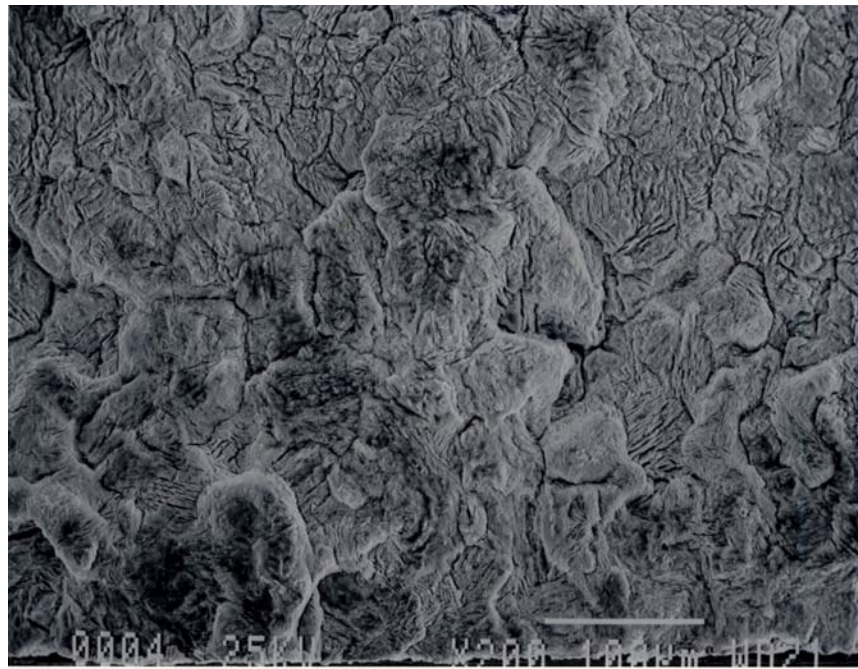
Figure C-15. Higher magnification of the intergranular attack noted at origin no. 1 (Figure C-12) of Ft. Lewis specimen no. 3 (mag. 200H).

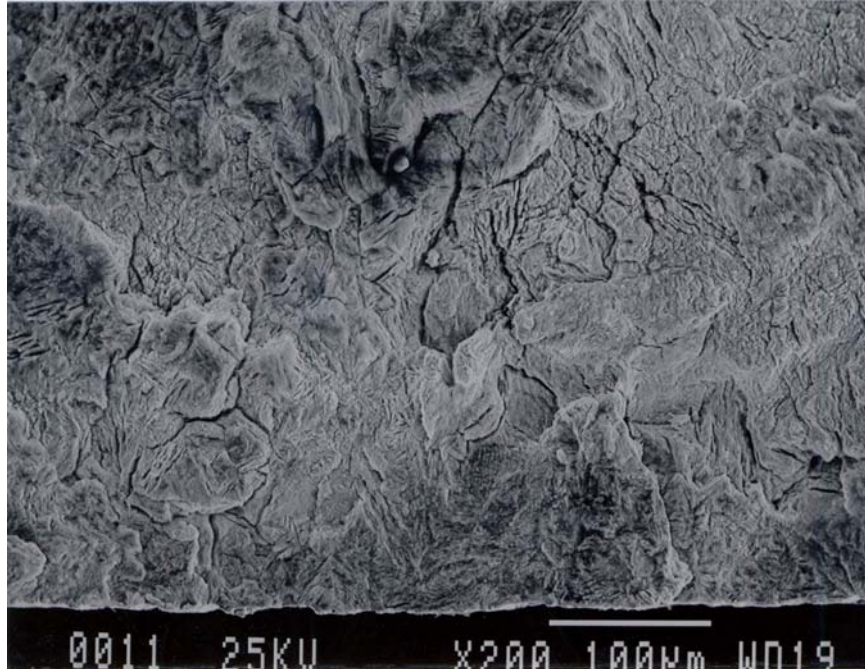
Figure C-16. Higher magnification of the intergranular attack noted at origin no. 2 (Figure C-13) of Ft. Lewis specimen no. 3 (mag. 200H).

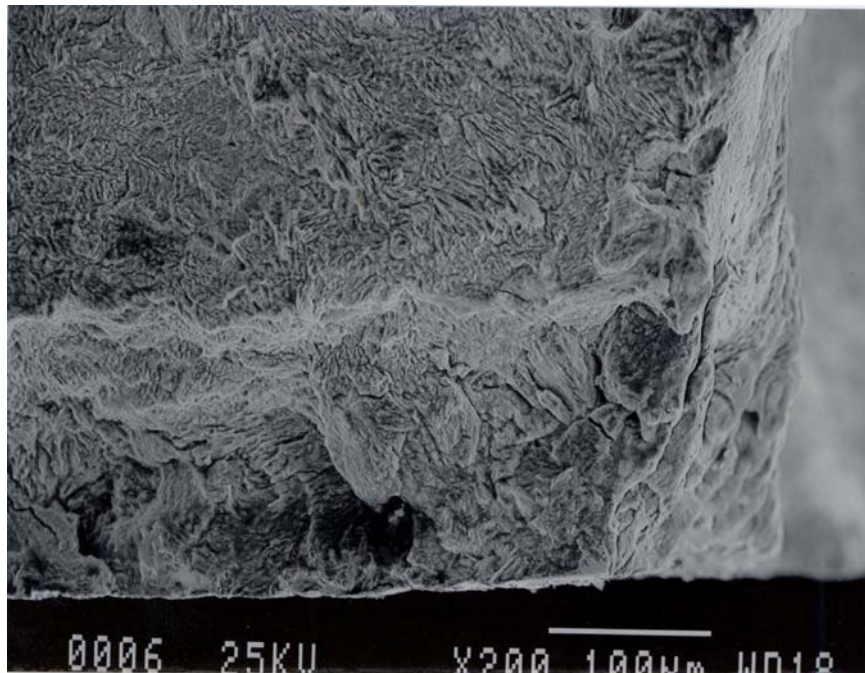
Figure C-17. Higher magnification of the intergranular attack noted at origin no. 3 (Figure C-14) of Ft. Lewis specimen no. 3 (mag. 200H).

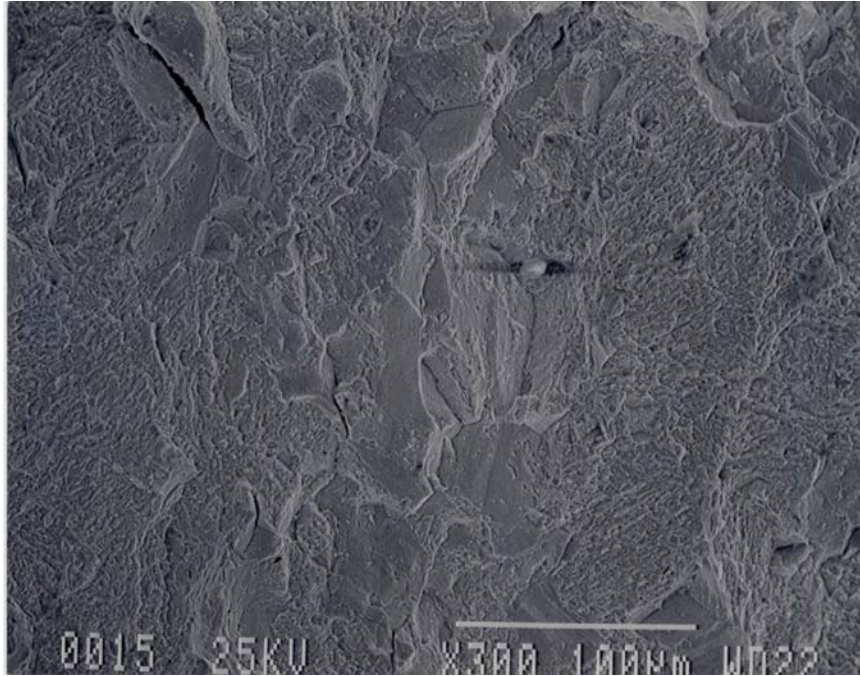
Figure C-18. Mixed mode morphology (intergranular and transgranular) noted close to origins within zone A Ft. Lewis specimen no. 3 (see Figure C-10) (mag. 300H).

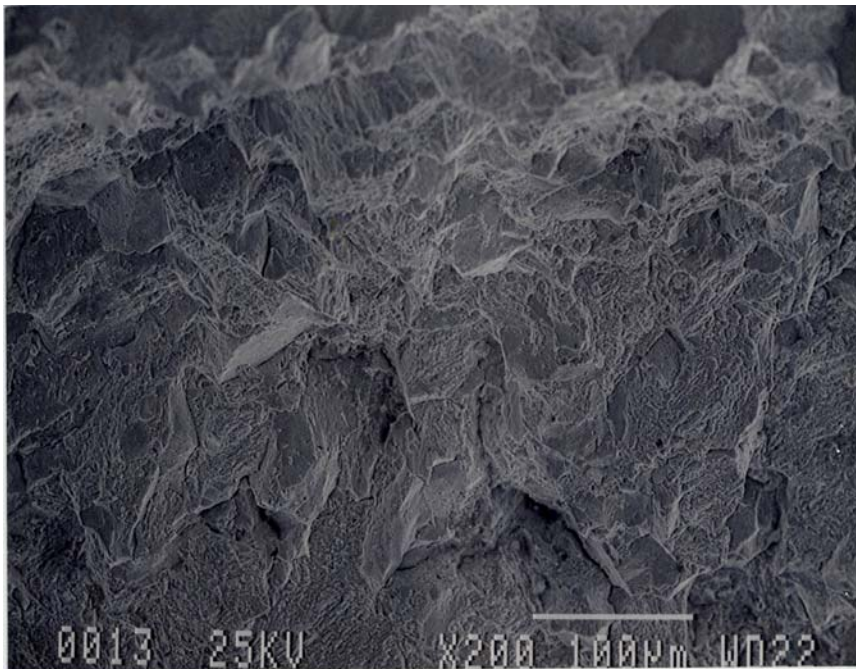
Figure C-19. Morphology noted further from origins (closer to final fast fracture region) within zone A Ft. Lewis specimen no. 3 (see Figure C-10) (mag. 200H).

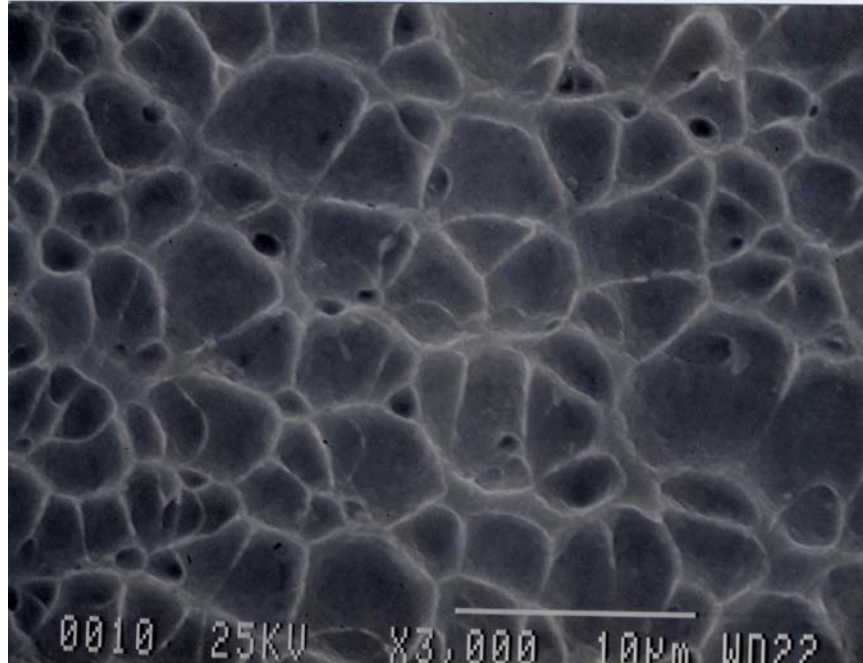
Figure C-20. Ductile morphology observed in the final fast fracture region (zone B) of Ft. Lewis specimen no. 3 (see Figure C-10) (mag. 200H).

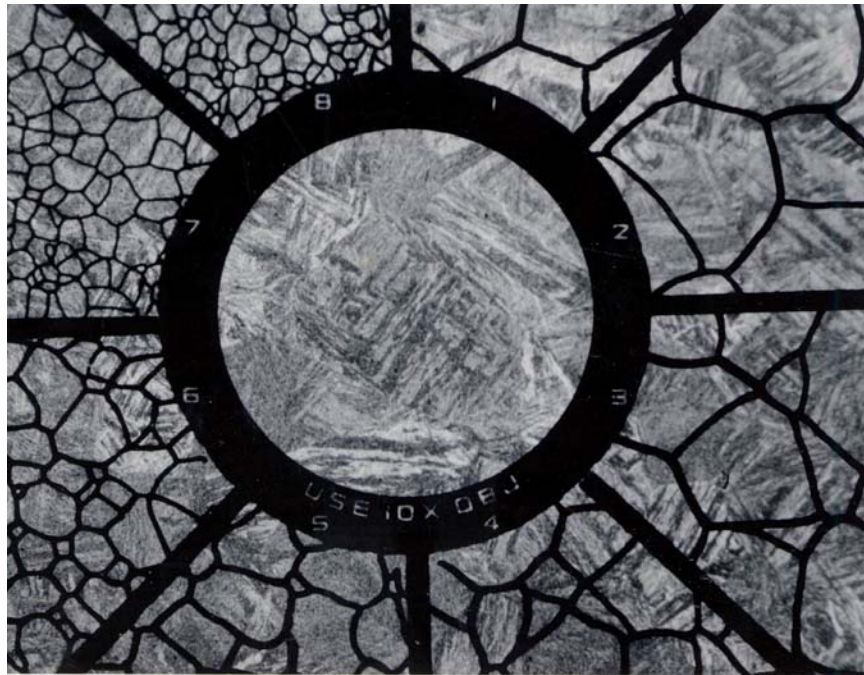
The grain size of failed Shock Strut Mount P/N 7-311113409, determined to be approximately double the required size (refer to section 2), was compared to the grain size of two scrap strut mounts. These strut mounts included one which had been sectioned into specimens that were cadmium brush plated at HAAF, Savannah, GA, and one that was sectioned for brush plating at Ft. Lewis, WA. The governing material specification, HMS 6-1081, *18% Nickel Maraging Steel - Bars and Forgings, 300,000 psi (2069 Mpa) Yield Strength Grade*, requires a grain size of no. 7 or finer with an occasional no. 5. It was determined that the grain size of the failed strut mount was between American Society for Testing and Materials (ASTM) nos. 2 and 3. Figure D-1 shows the grain size of the failed part, with a grain size reticle overlay at 100H magnification. Figure D-2 shows a scanning electron micrograph of the actual grain size observed within the intergranular fracture surface at 200H magnification.

Figure D-1. Grain size of the failed strut mount with reticle overlay (mag. 100H).

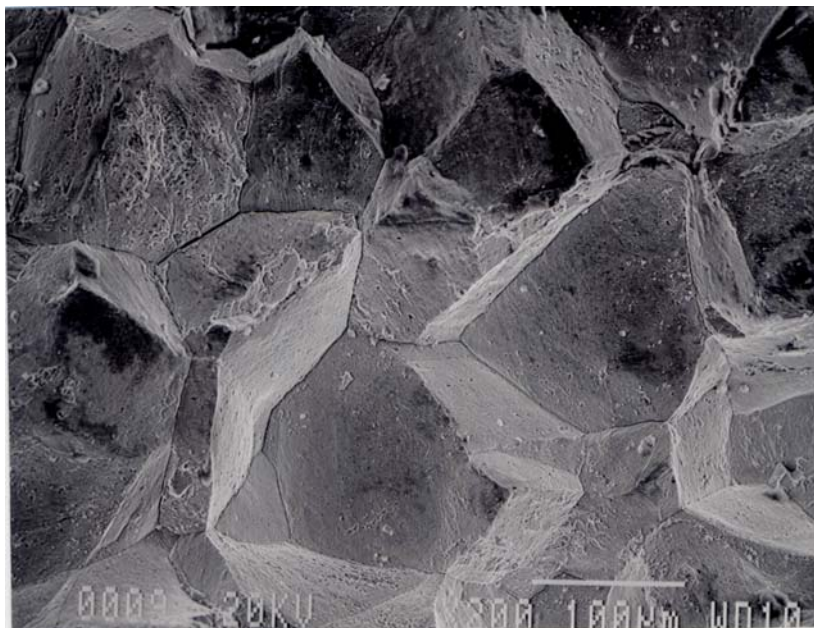
Figure D-2. Grains from the intergranular fracture surface of the failed strut mount (mag. 200H).

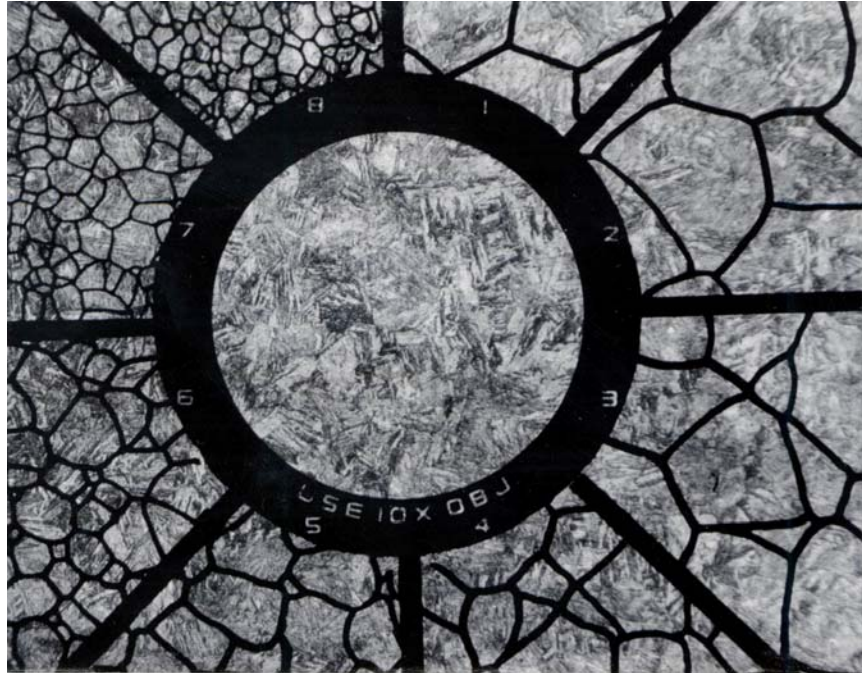
Figure D-3. Grain size of the HAAF specimen with reticle overlay.  
Compare to Figure D-1 (mag. 100H).

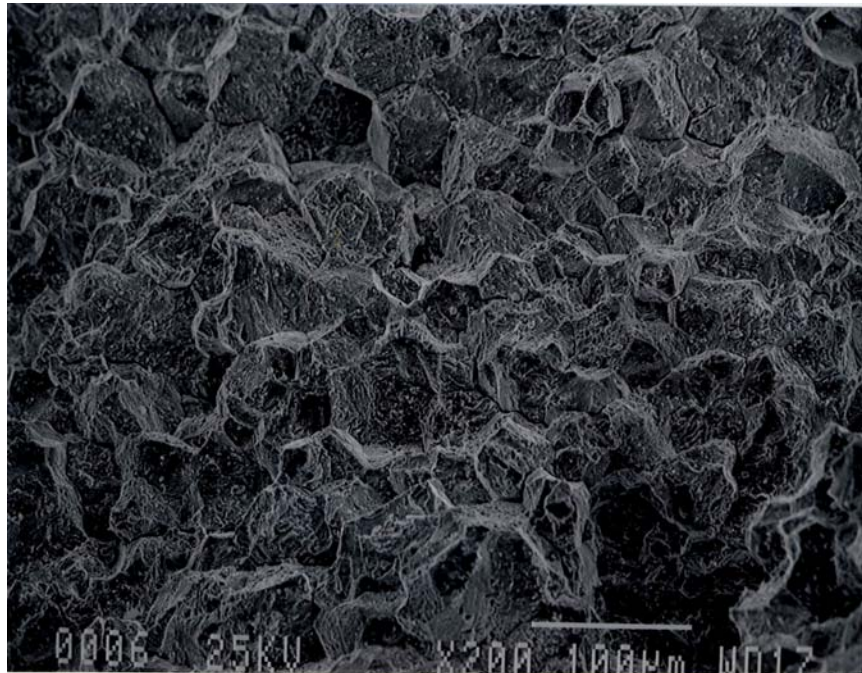
Figure D-4. Grains from the intergranular fracture surface of the HAAF SCC specimen. Compare to Figure D-2 (mag. 200H).

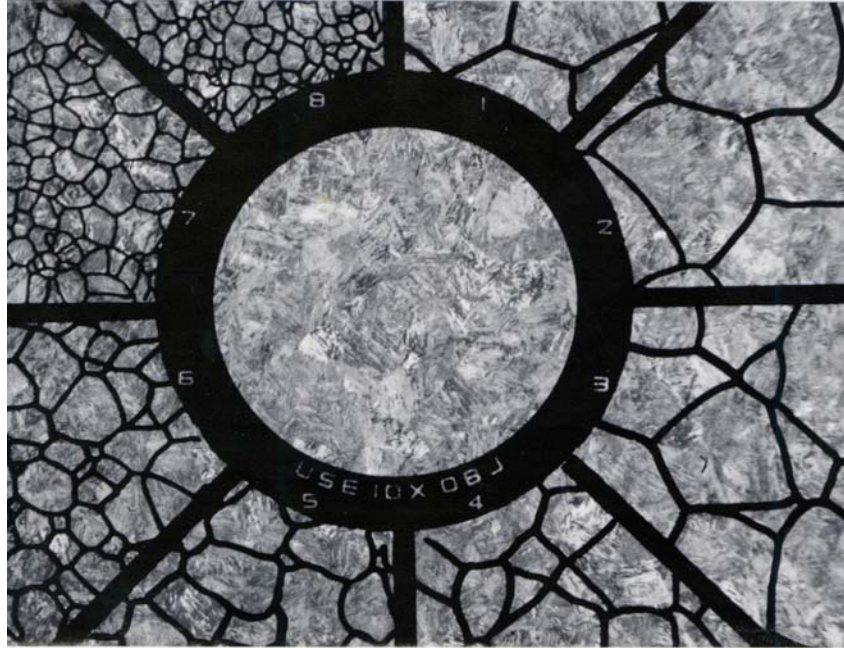
Figure D-5. Grain size of the Ft. Lewis specimen with reticle overlay. Compare to Figure D-1 (mag. 100H).

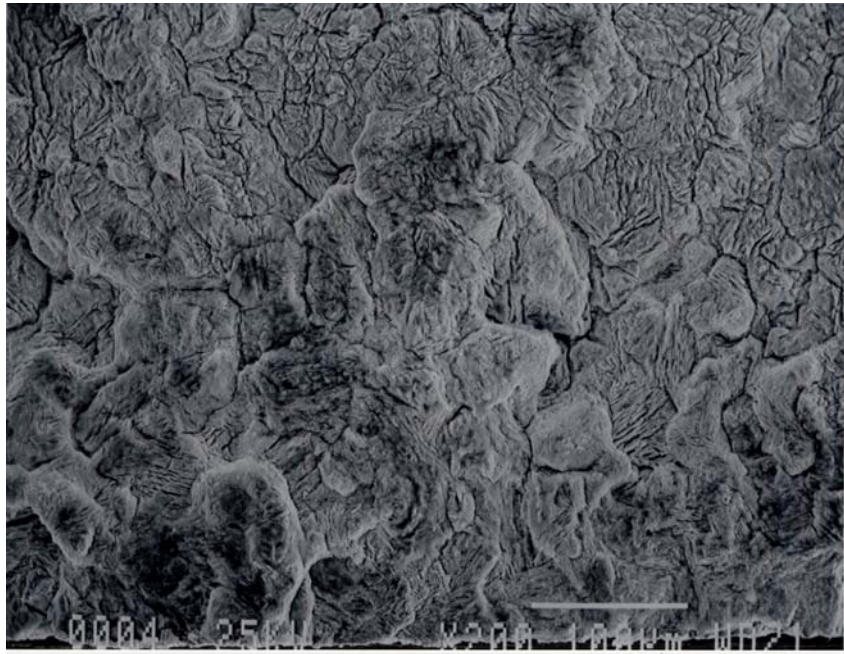
Figure D-6. Grains from the intergranular fracture surface of the Ft. Lewis SCC specimen. Compare to Figure D-2 (mag. 200H).
